# Investigation of Failures of White-Coat Plaster

United States Department of Commerce  
National Bureau of Standards  
Building Materials and Structures Report 121

Building Materials and Structures Report 121

Issued February 1, 1951

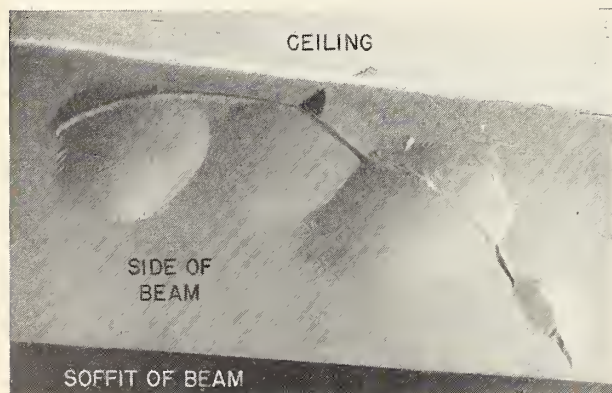
Failures in the white coat of plaster over concrete bases were of frequent occurrence. Figure 1 shows a series of bulges on the side of a concrete beam. In this case, the bulging was confined entirely to the white coat. On breaking these bulges it was found that the underlying coat of gypsum bond plaster (which had been applied directly over the concrete) had been well scratched, was hard, and still attached firmly to the beams.

FIGURE 1. A series of bulges in white coat along the side of a concrete beam, caused by the expansion attending the slow hydration of free  $MgO$  in the hydrated lime used in preparing the white coat.

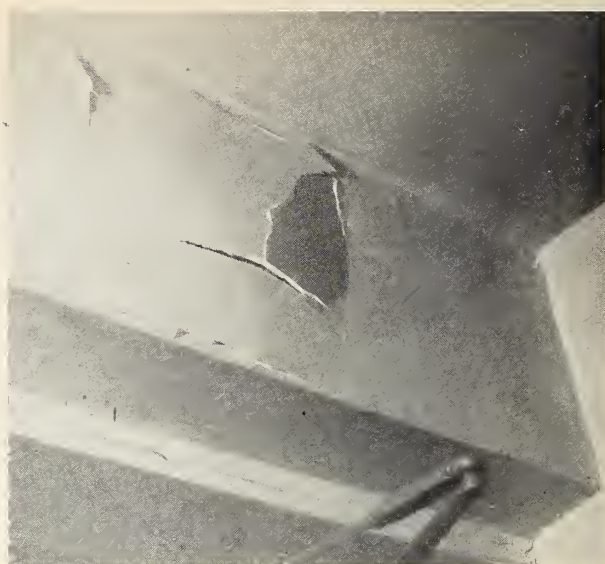
Figure 2 shows bulging white coat along the side of a concrete beam located above a door in an inside stairway of an eight-story fireproofed apartment house built in 1924. Here, again, the failure was confined to the white coat; the underlying gypsum bond plaster was still adhering tightly to the concrete base. Failures are also taking place in the white coat on the ceilings and side walls. There has been no trouble with the underlying base coats of sanded gypsum plaster. Failures started in this building about 7 years after the building was erected.

FIGURE 2. Bulging white coat along the side of a concrete beam located above the door of an inside stairway in an eight-story fireproofed apartment house.

The underlying gypsum bond plaster was still adhering tightly to the concrete base.

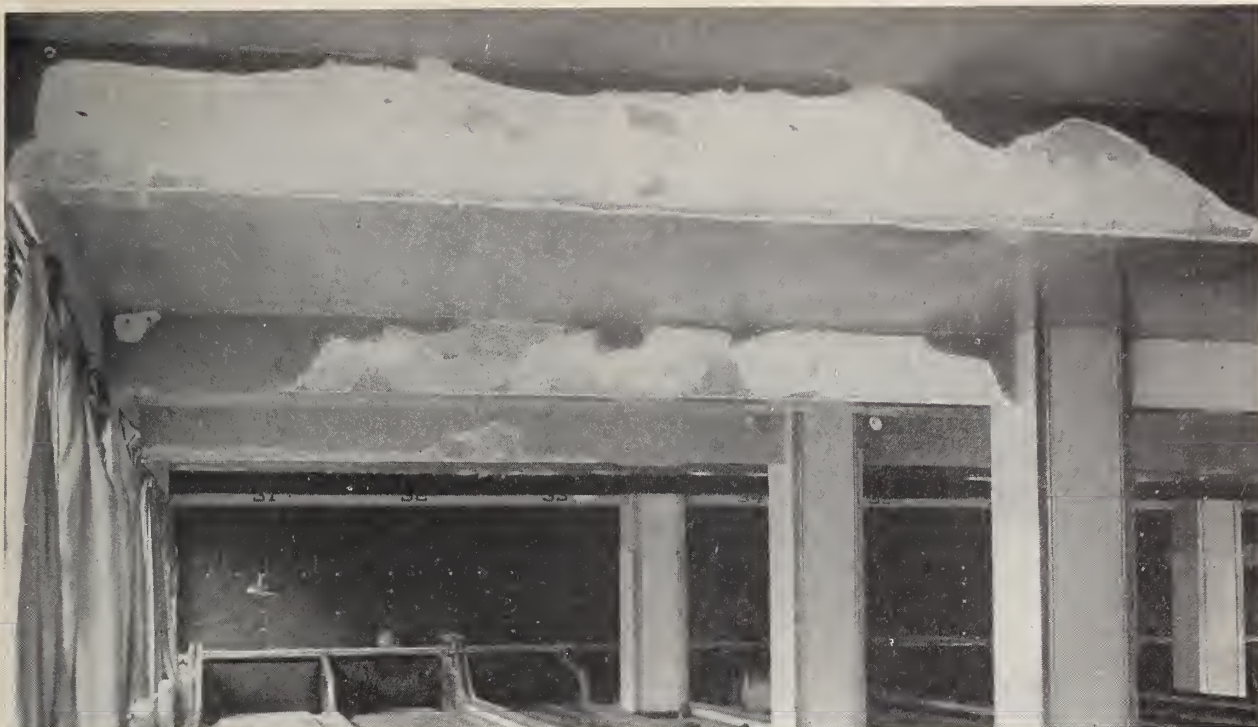
was being made to keep in repair the white-coat finish. In fact, the failures had occurred so frequently that the owner of the bowling alleys found it cheaper and more advantageous to hang velvet drapes in front of the concrete beams to hide their unsightly appearance rather than to replaster the beams repeatedly. Inasmuch as the bulged and loose plaster had been removed before the concrete beams were photographed, the picture reveals where the failures had occurred. For the most part they were at the bond between the successive layers of white coat, applied to straighten up the beam, rather than between the white coat and scratch coat of neat gypsum bond plaster. Only in very limited areas was there any separation of the bond plaster from the concrete.

FIGURE 3. *Failures in white coat along sides of concrete beams over bowling alleys.*

The failures caused by the expansion of the white coat were confined almost entirely to loosening of the bond either between successive layers of white coat or between the white coat and the gypsum bond plaster. Only in very limited areas was there any separation of the bond plaster from the concrete.

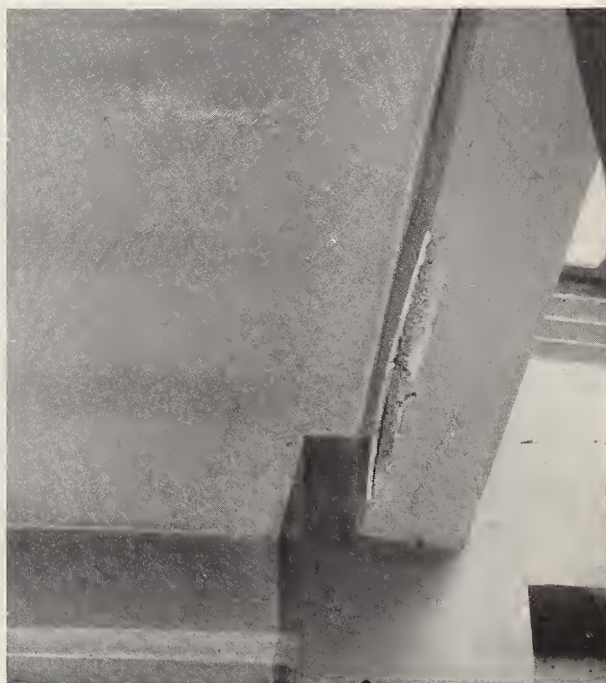
FIGURE 4. *Bulging white coat along the edge of the soffit and side of a concrete beam in an office building.*

Note the old patch in the white coat in the ceiling.

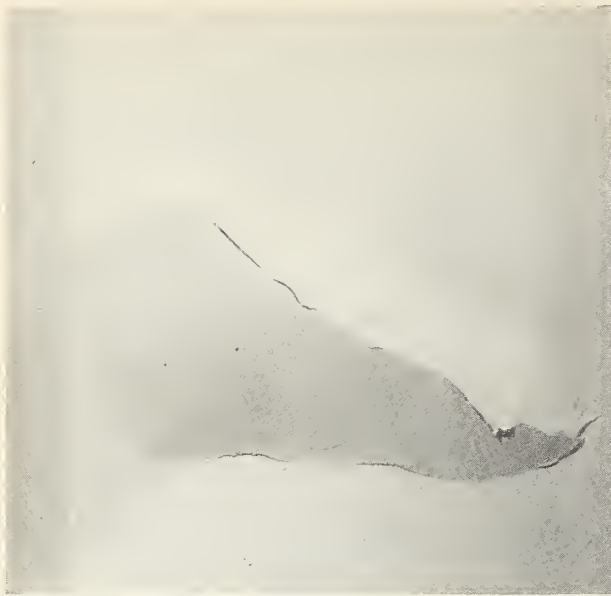
FIGURE 5. *Large bulge of white coat on a concrete pilaster in a school building.*

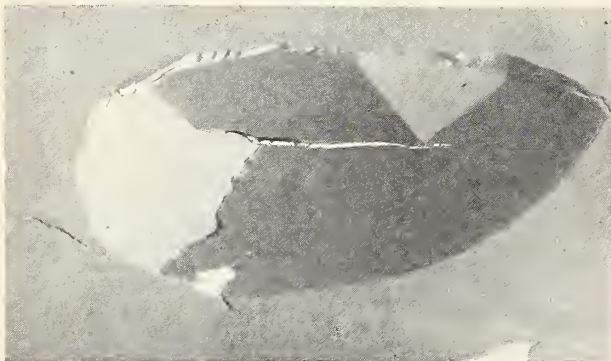
Figure 6 shows a white-coat blister, cracked and bulging from an underlying sanded gypsum brown coat on a plastered ceiling, but still held

FIGURE 6. *Cracked bulge of white coat on a ceiling, still held suspended by a film of paint.*

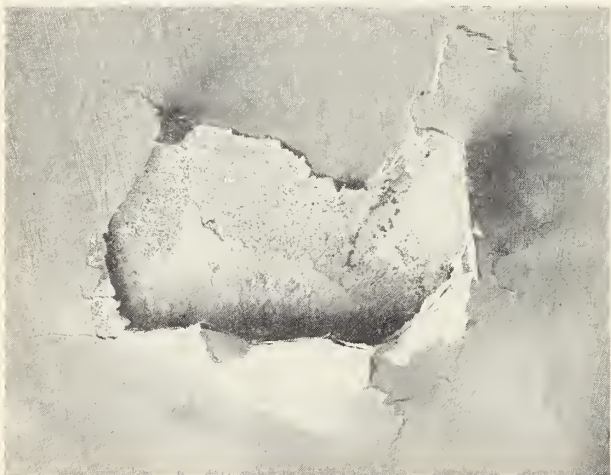
FIGURE 7. *All that remained after a bulge of white coat fell from a ceiling of an office building.*

Note the firm underlying brown coat of sanded gypsum plaster and a thin layer of white coat still intact.

Figure 7 shows the loosely held remains of a shattered blister after the missing portion had fallen from the ceiling, thus revealing the firm underlying brown coat of sanded gypsum plaster and a thin layer of adhering white coat still intact. The plaster base of the ceiling was composed of concrete joists with hollow-ceramic-tile fillers.

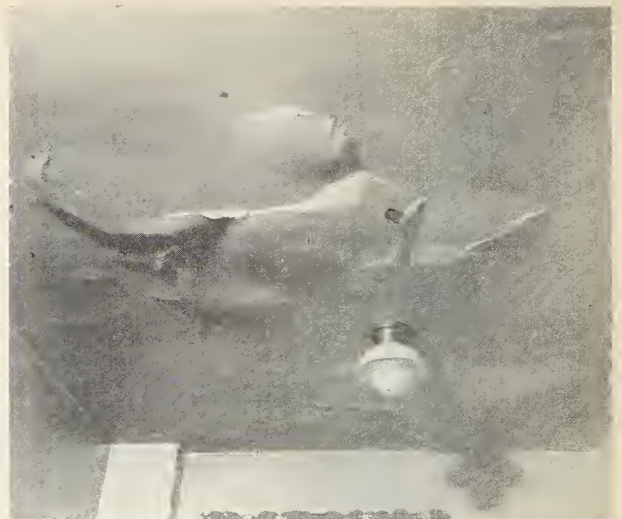
FIGURE 8. *A kitchen ceiling in an apartment house; revealing pronounced bulging in the white coat, caused by expansion.*

Note the small patches previously applied.

An example of pronounced bulging of white coat is illustrated in the photograph of a kitchen ceiling in an apartment house (fig. 8). Figure 9

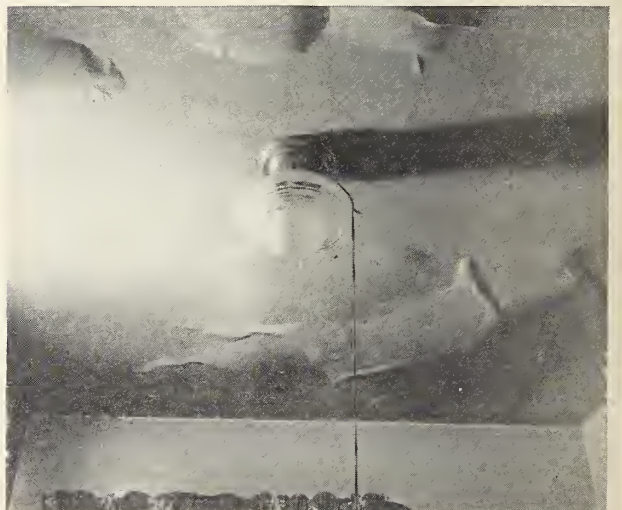
FIGURE 9. *A more detailed photograph of the bulges shown in the background of figure 8.*

presents in greater detail the bulge in the background of figure 8. Trouble had started about 7 years after the building was erected and had continued for 18 years up to the time of the inspection. White-coat-plaster failures had occurred on the side walls also. There had been very little trouble with the sanded gypsum base coats on ceilings and side walls.

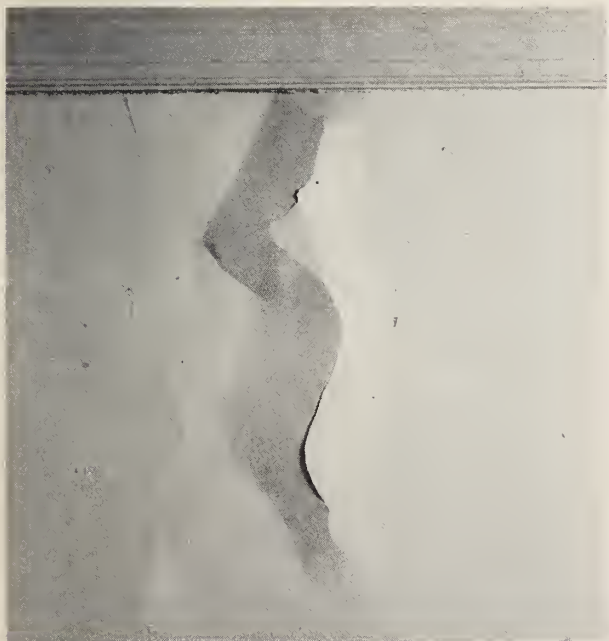
Figure 10 shows a large bulge of white coat protruding from a sanded base coat on a side wall and extending downward from the plaster moulding for about 2½ feet. There was no evidence of poor workmanship in the plastering. The 12-story building was of reinforced-concrete construction with hollow-ceramic-tile partitions. No details were obtained as to when failures began nor as to their extent each year, but at the time of the inspection, 27 or 28 years after the building was completed, a great deal of trouble was being experienced with the white-coat plaster throughout the building. White-coat-plaster failures were as extensive on the ceilings as on the side walls. The gypsum sanded base coats on the side walls were in good condition.

FIGURE 10. A large bulge of white coat extending about 2½ feet downward from a cast gypsum plaster moulding.

The photograph was taken in a corridor of a 12-story building of reinforced-concrete construction with ceramic-tile partitions. The building, originally designed and occupied as a hotel, was later converted to an office building. No expense had been spared in the plastering work.

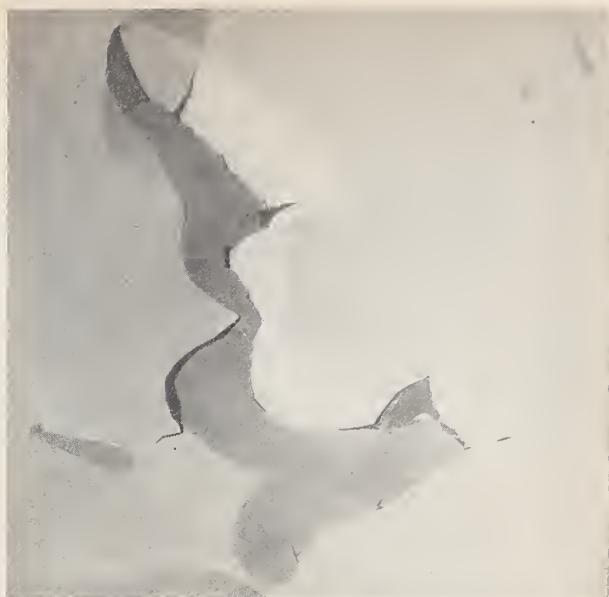
Figure 11 shows the bulging of white coat, involving separation of this coat from the gypsum sanded base coat within an area of about 1 square yard. This is a photograph of the side wall of an inside stairway of an apartment house where there were several similar failures in the white coat.

FIGURE 11. Bulging of white coat on a side wall, involving separation from the sanded gypsum base coat within an area of about 1 square yard.

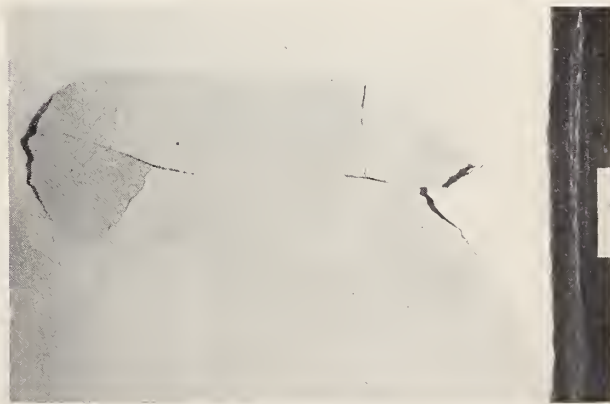
Figure 12 shows a bulge of white coat on the side wall of another building. In this case the backing was wood lath.

FIGURE 12. Bulge of white coat on the side wall next to a door jamb.

The firm base coat of sanded gypsum plaster was applied over wood lath.

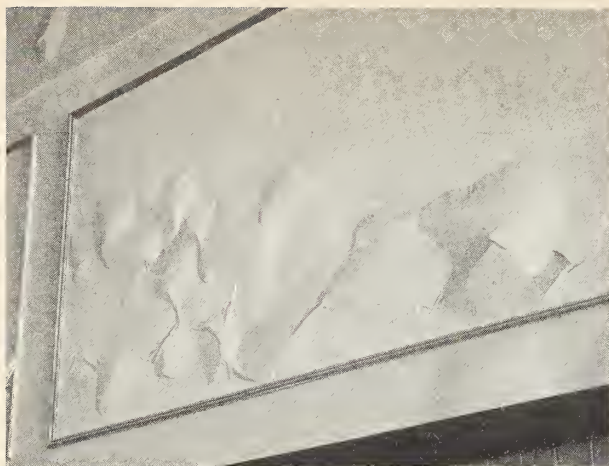
An example of extensive white-coat failure is shown in figure 13. This is a side-wall panel in a shop of a store and office building. The gypsum brown coat underneath this white coat was firm and well bonded. The white coat in an adjoining panel had been replaced, and the members of the inspection committee were told that the bulges in this panel were even more pronounced than those shown in figure 13.

FIGURE 13. Series of white-coat bulges along the side wall of a plastered panel in a shop of a store and office building.

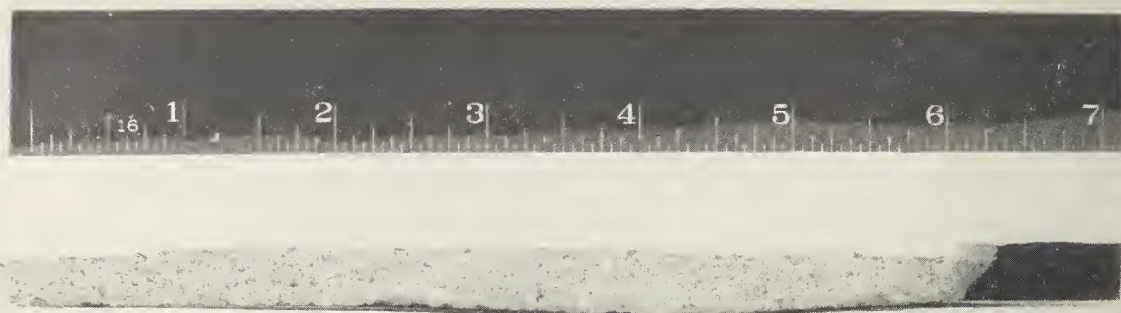
FIGURE 22. A cross section of white coat adhering to a sanded gypsum plaster base coat that had been applied over a concrete beam.

Photograph made prior to autoclaving.

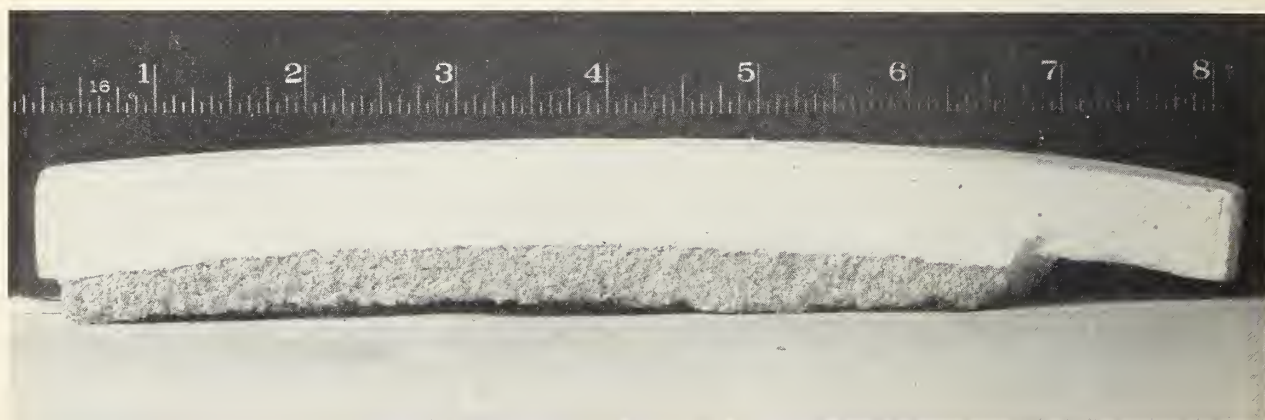
FIGURE 23. The specimen shown in figure 22, after autoclaving.

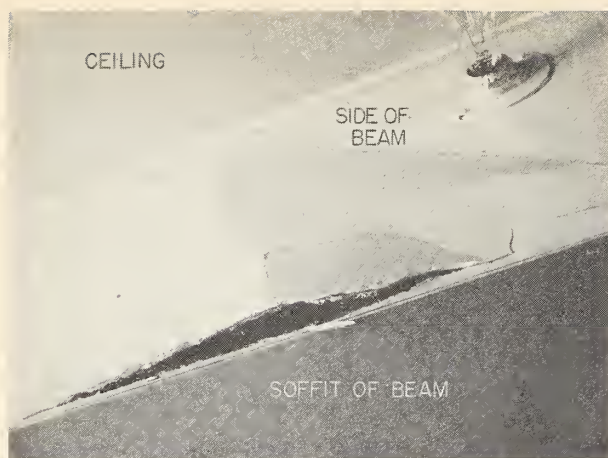
FIGURE 24. Plaster failure involving an expansion of about 0.5 percent in the white coat along the side of a concrete beam.

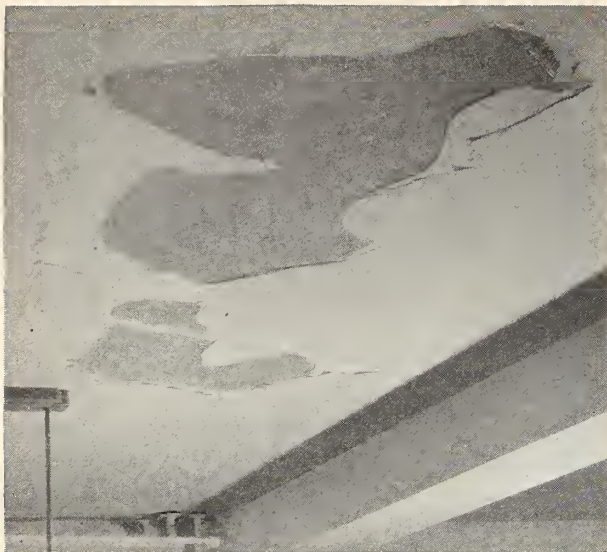
FIGURE 27. A ceiling in an office building where white-coat plaster failures are of frequent occurrence and where repatching has been going on for years.

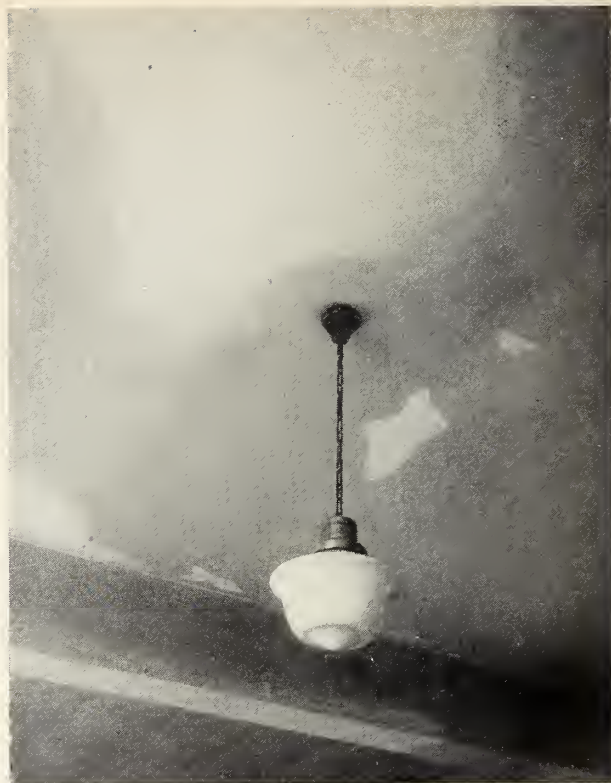
Figure 28 shows a plastered ceiling with an extensive area that had been patched because of the loosening of the white coat. But, more important, it shows additional white-coat-plaster failures that occurred subsequent to the patching but before the painter got around to redecorating the ceiling. Faced with the continuous reappearance of bulged and defective areas, it was finally decided that the

FIGURE 28. An extensive area of patched white coat and additional areas of delaminated white coat that occurred subsequent to patching.

best policy in this parochial school would be to cover the ceilings with some material that would not undergo excessive expansion with seasonal changes. Hence, the selection of pressed metal as a ceiling material. Note in figure 29, however, that bulges are still appearing in the white coat on the concrete beams.
